What Lies Beneath

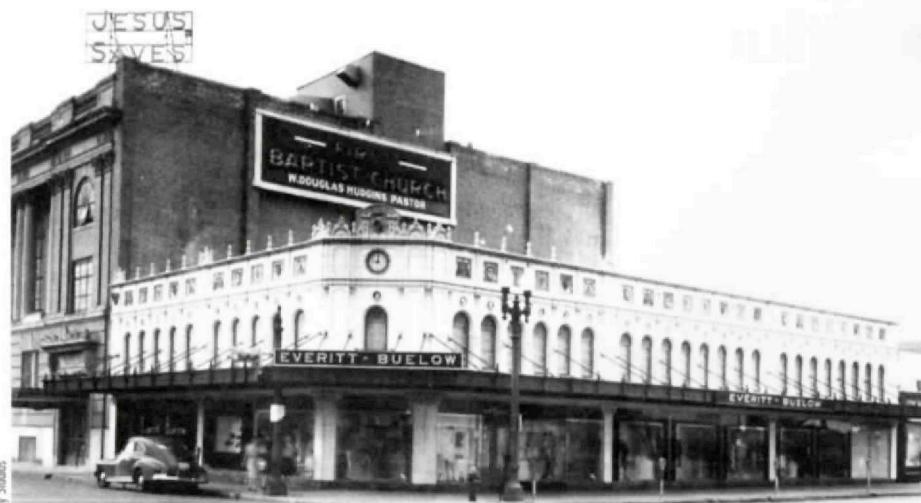
Corner of Main and Lamar, 1940s: A building in the ornate Spanish Renaissance Revival style could bring stylistic diversity downtown.

home to Everitt-Buelow Clothiers—led to the discovery of intact arched steel sash casement windows behind storage shelving lining the outer walls. These windows had been hidden from exterior view for years by a slipcover of travertine panels. Upon further investigation of the 16-inch space between the original façade and the newer stone panels, glimpses of glazed terra-cotta acanthus leaves, medallions, Corinthian pilasters, and other ornate architectural detailing were seen. Photos taken of the building sometime in the 1940s confirmed that behind the blank travertine there was an exquisite Spanish Renaissance Revival façade.

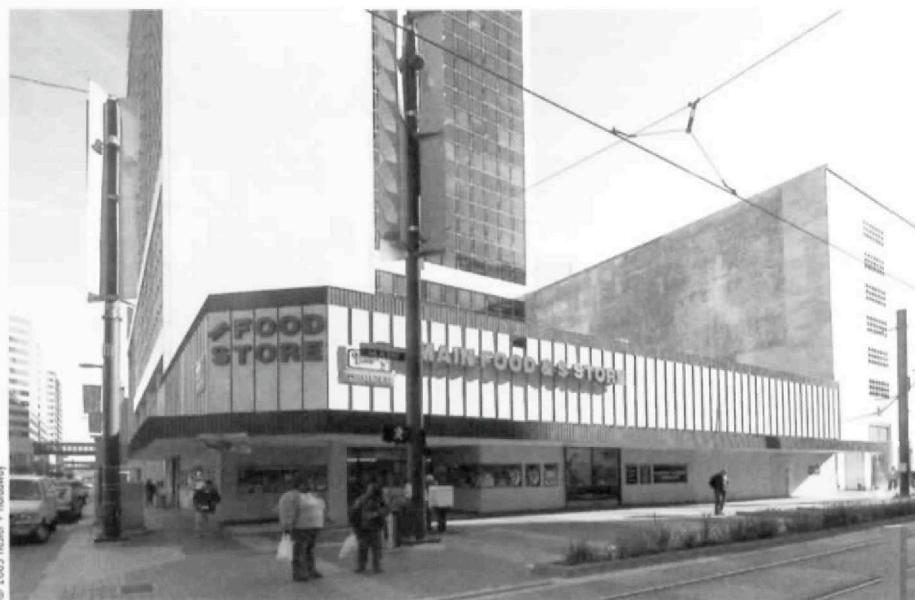
Corner of Main and Lamar, today: The building still stands, but the historical façade lies covered up by unlovely travertine panels.

A visit to the unoccupied second floor of the unimpressive commercial building at Main and Lamar—formerly
